**LOWER WOODS  
POND DAM**

PHASE I INSPECTION REPORT  
NATIONAL DAM INSPECTION PROGRAM

6 National Dam Inspection Report. Lower Woods Pond Dam (PA-00152, DER I.D. 64-11), Delaware River Basin, E. Branch Dyberry Creek, Wayne County, Pennsylvania. Phase I Inspection Report.

LOWER WOODS POND DAM  
WAYNE COUNTY, PENNSYLVANIA

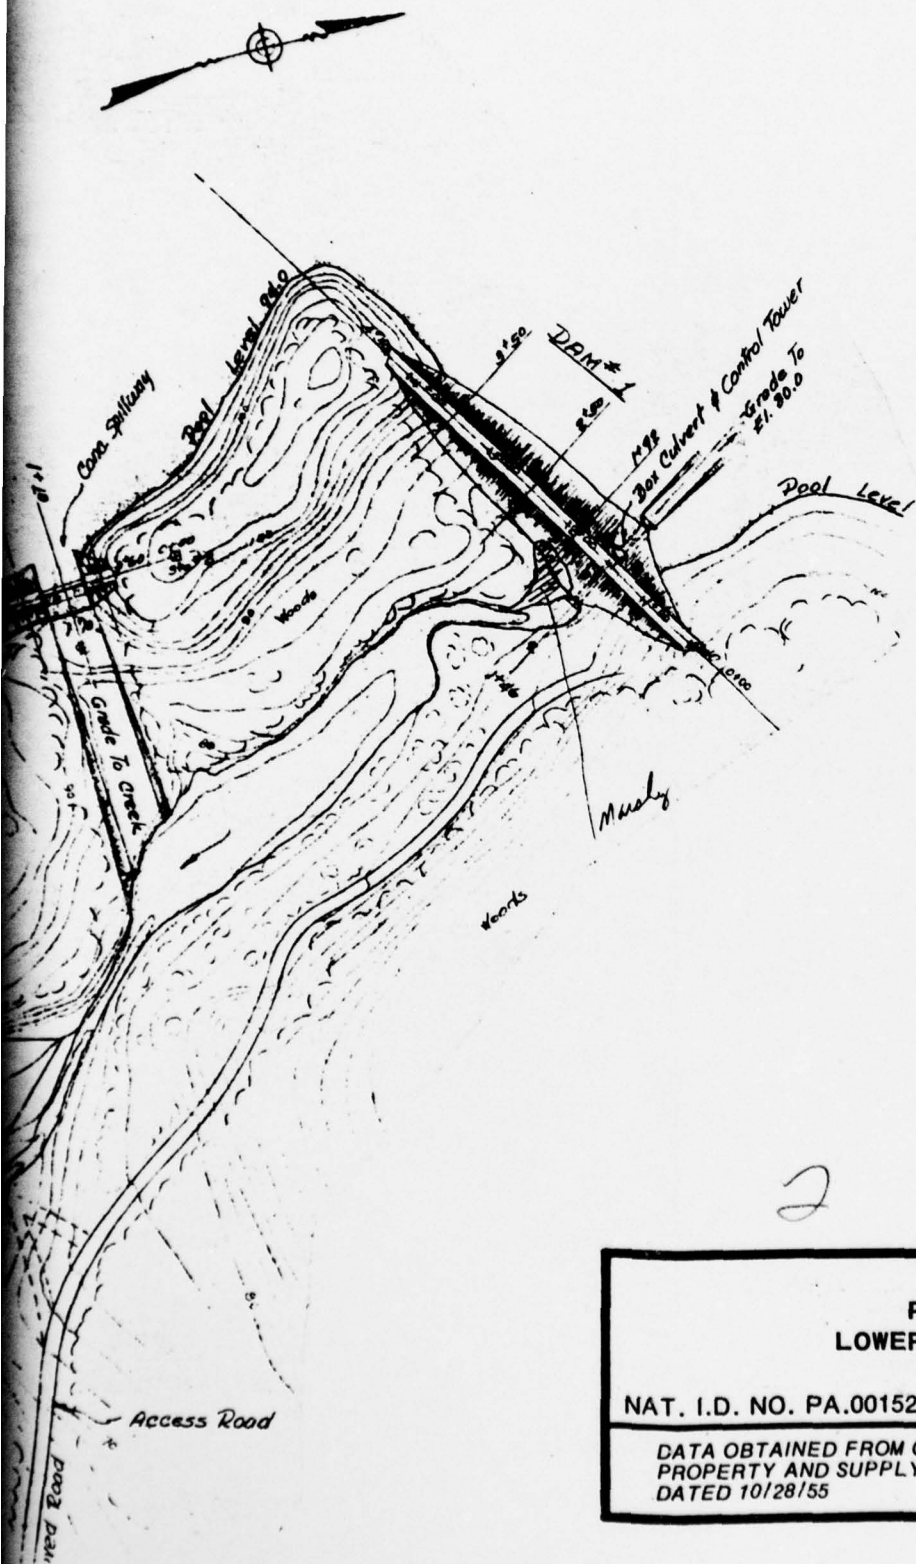
PLATE 2

PLAN OF DAMS  
LOWER WOODS POND DAM

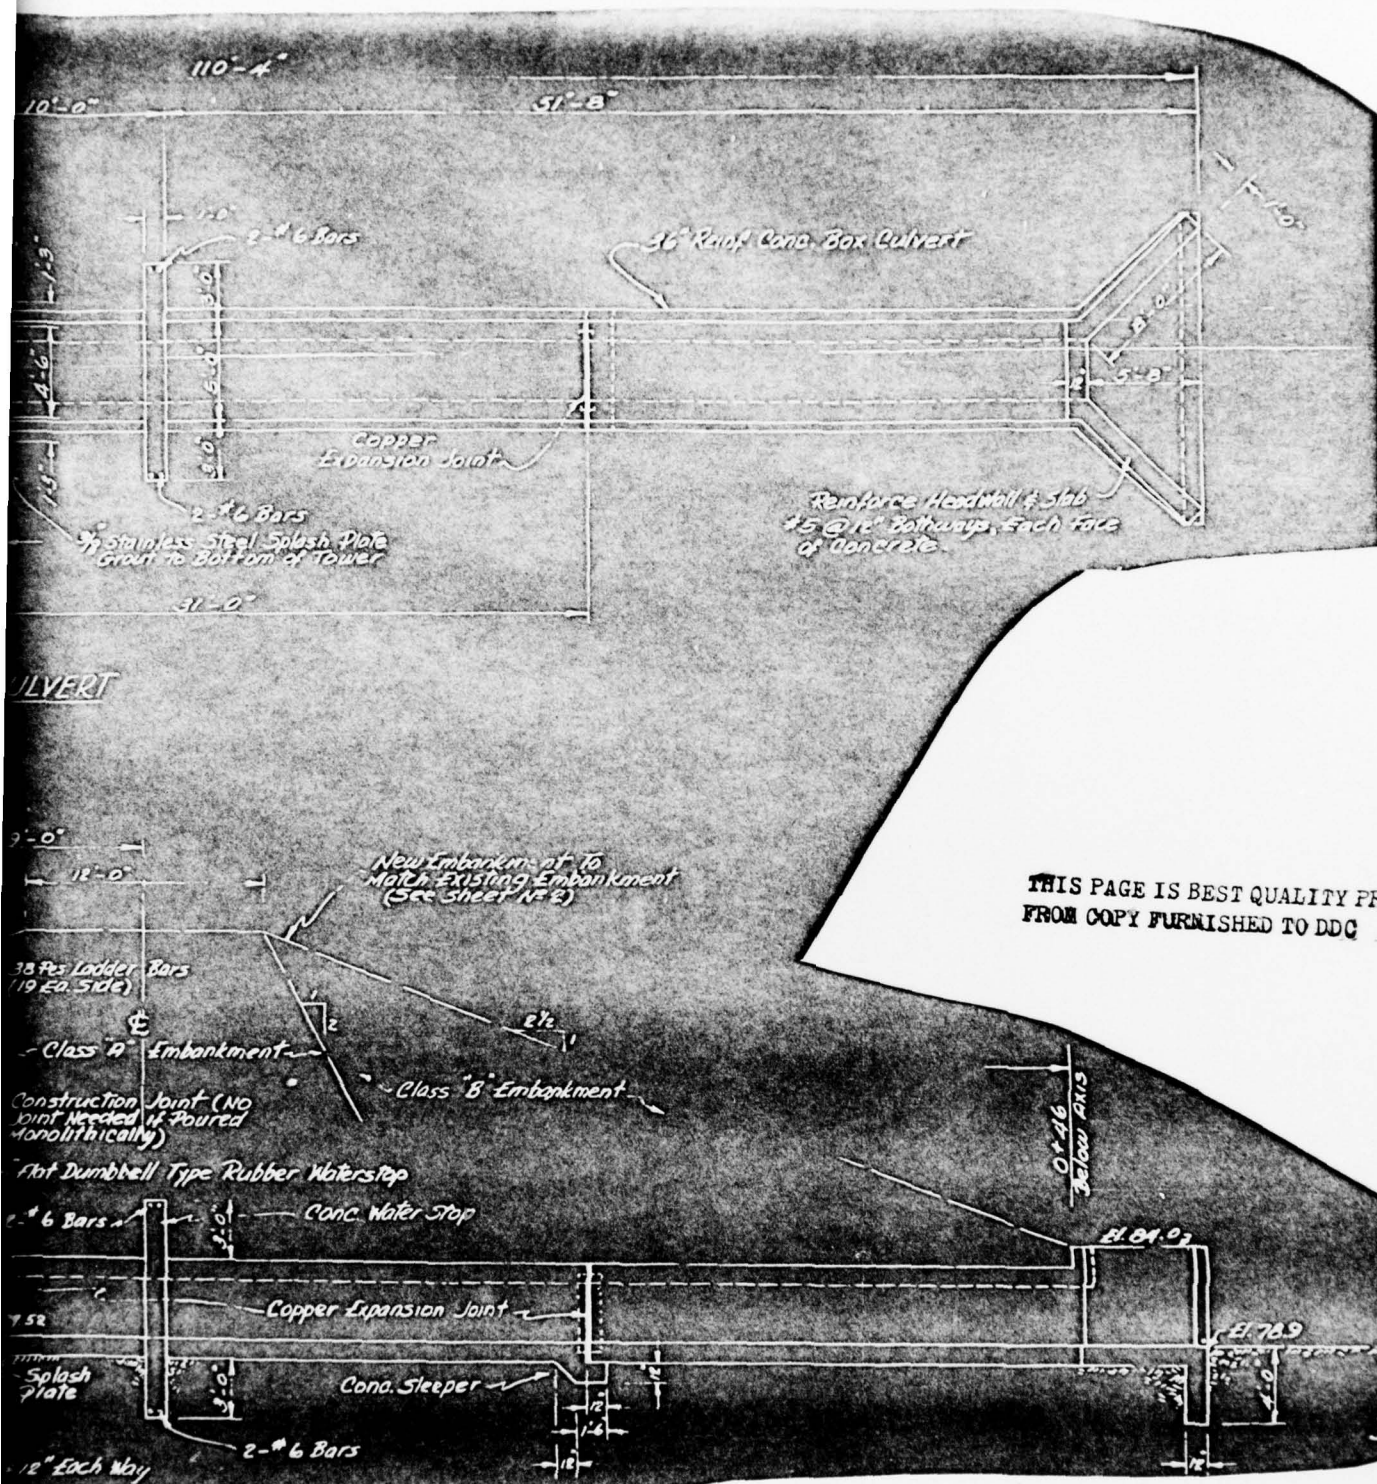
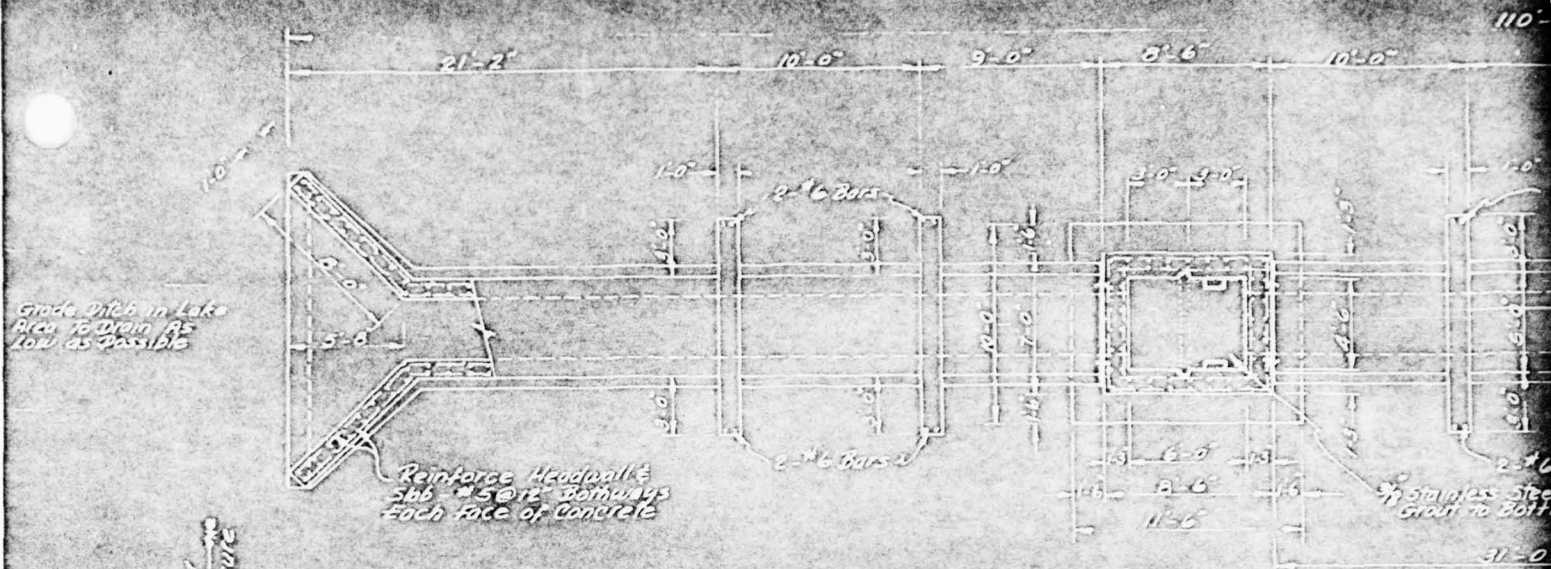
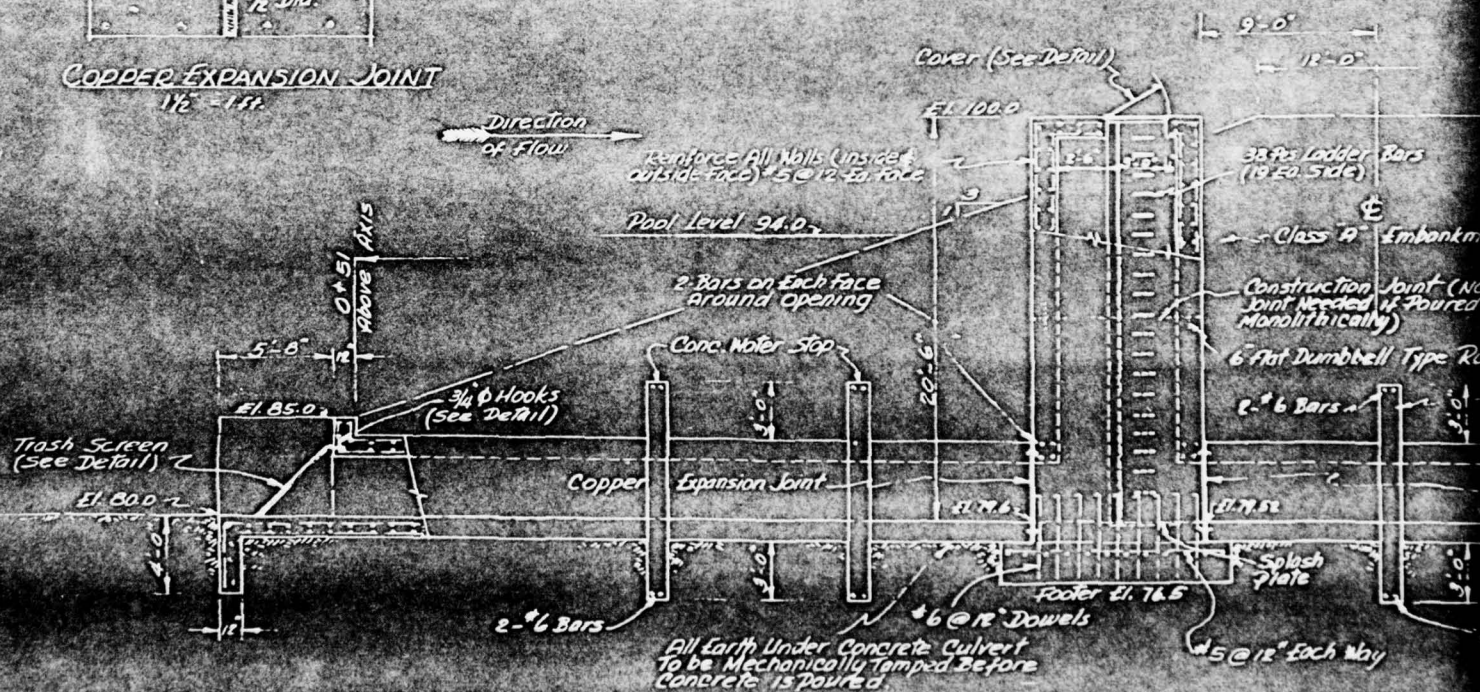
PLATE 3

Dam No. 1 was redesigned with a standard Pennsylvania Fish Commission intake tower located within the embankment immediately upstream of the centerline. The tower contains an interior overflow weir formed by stoplogs. Water enters the tower through a 3 foot by 3 foot concrete conduit extending from the upstream toe through the embankment to the intake tower base. A 3 foot by 3 foot concrete conduit discharges from the tower to the downstream toe. The conduit entrance invert elevation is 1,398 feet, and the exit invert elevation is 1,396.9. The crest of the stoplog weir can be varied, but it is reported to be at approximately normal pool level of about elevation 1,412. There are three anti-seep collars around the conduit. Two are located upstream and one is located downstream of the tower. (See Plate 3, Appendix E.)

# PLAN AND PROFILE OF PRINCIPAL SPILLWAY LOWER WOODS POND DAM
